JACOB'S WELLS BATHS

APRAISAL OF THE WATER SYSTEM

April 2024 Revision 1

G.J.O. Wallis C.Eng. MIMech.E Engineering Consultant
www.gwconservation.com

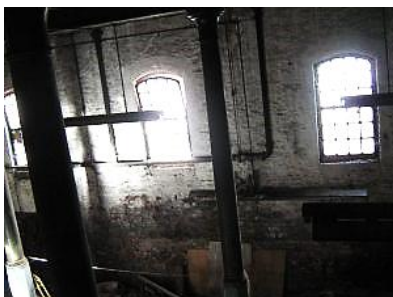
A view of the windows on the south elevation of the boiler house before being boarded up. The boiler house must have been well-lit by natural light. Photograph: Mike Britton 2016.

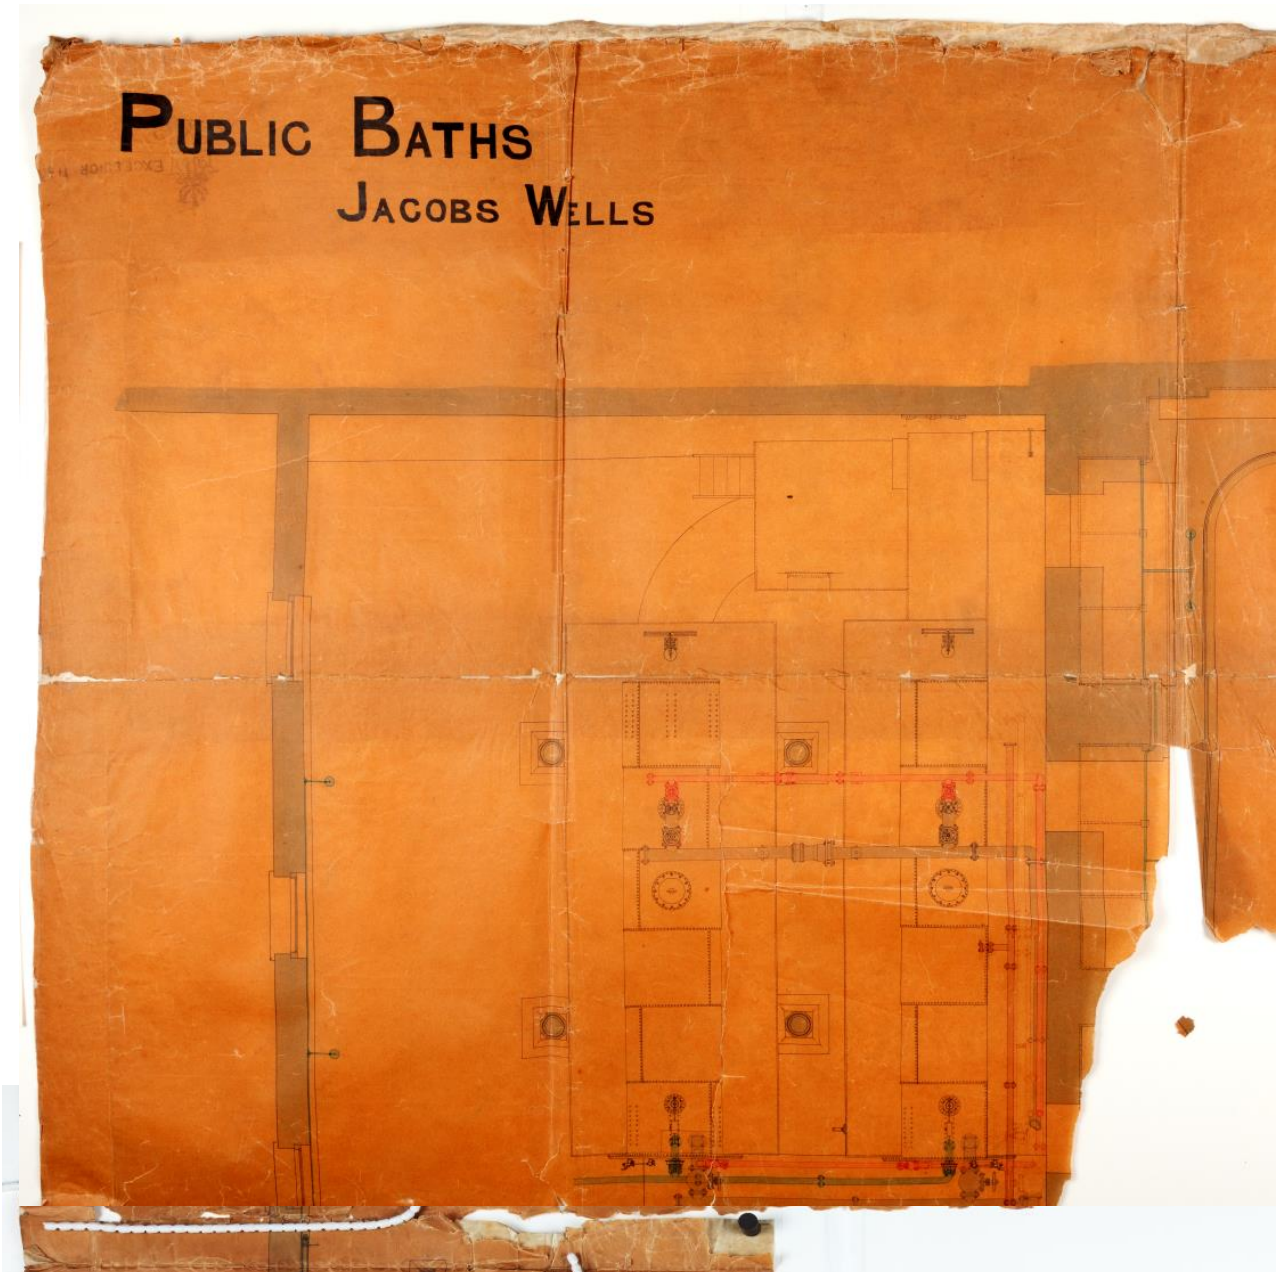
This original plan of the boiler house shows two single furnace ‘Cornish’ boilers with riveted shell-plates. The flues and dampers can be seen at the west end, and mid-way along the boiler, man-hole covers allowing entry to the boilers for inspection, cleaning and maintenance are visible.

There appear to have been two water circuits: a high temperature flow and return for showers and baths drawn in red, and a lower temperature circuit to and from the pool. The supplies are taken from the top of the boiler mid-way along it, and the returns are at the front end (bottom of the image), probably at mid height in the lower half of the circular boiler front-plate.

At the east end can be seen cold water feed pipes, pressure-relief valves, and gauge-glasses which showed the level of water in the boiler.

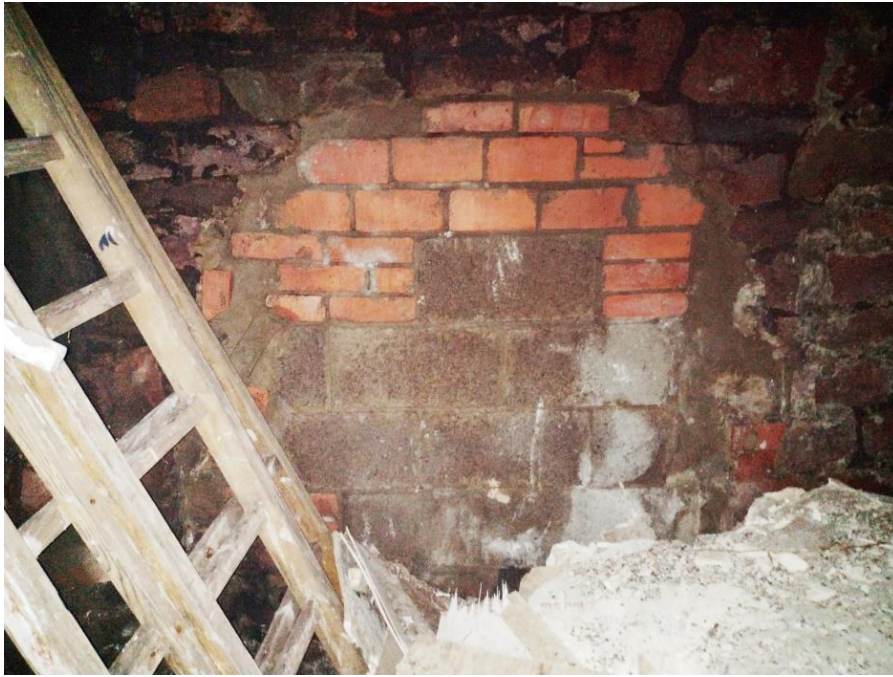
The bricked-up entrance to the horizontal flue can be seen on the west wall of the boiler house

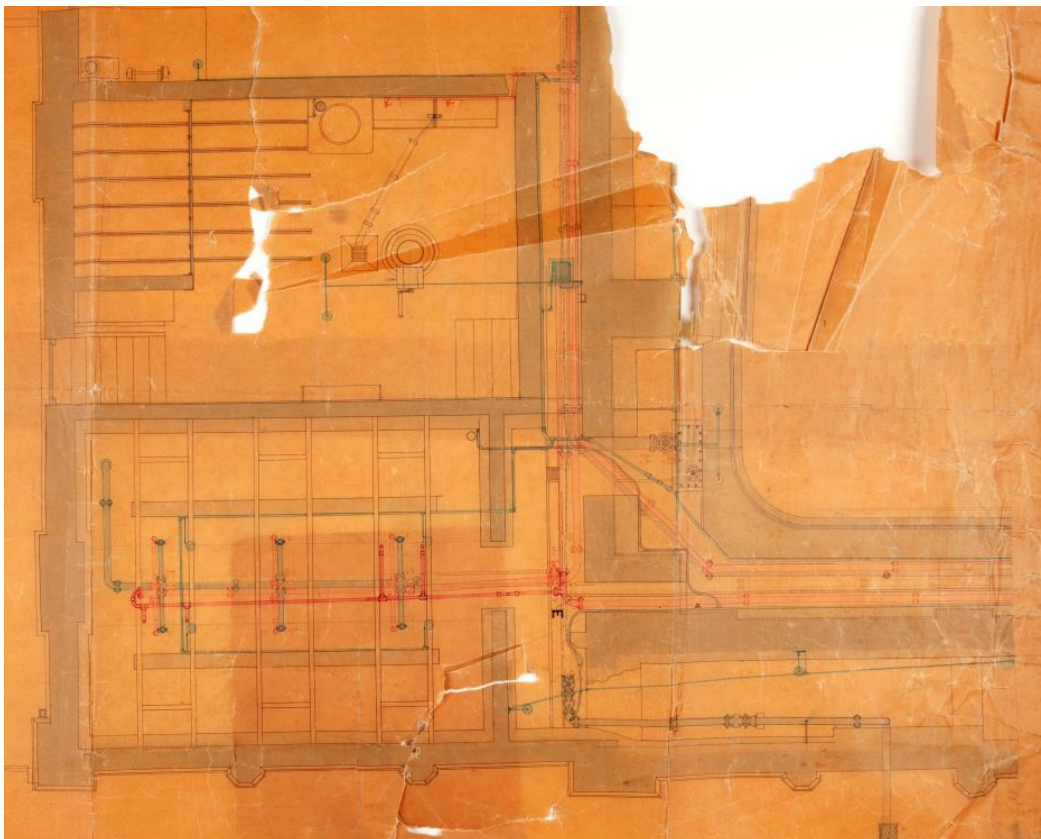
Pipework detail for six women's hot baths and the towel wash house. For a higher definition image please refer to the Appendix.

These incomplete fragments of drawing show the hot and cold supplies to the mens' facilities to the north of the pool. (See also a higher definition image in the Appendix)

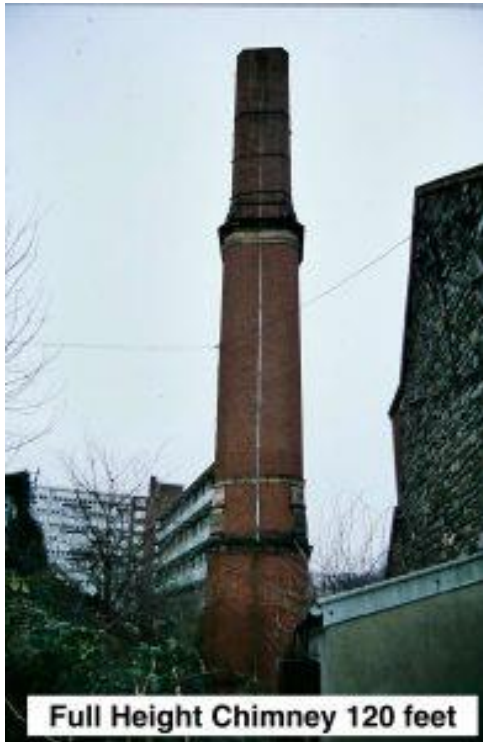
This photograph from Bristol Community Dance Centre archives shows the chimney.

The chimney stack was 120 feet high, in a gap between two hillsides, Cliftonwood Slopes and Brandon Hill.

Shortly after 2006 it was reduced in height due to worries about stability in storms.

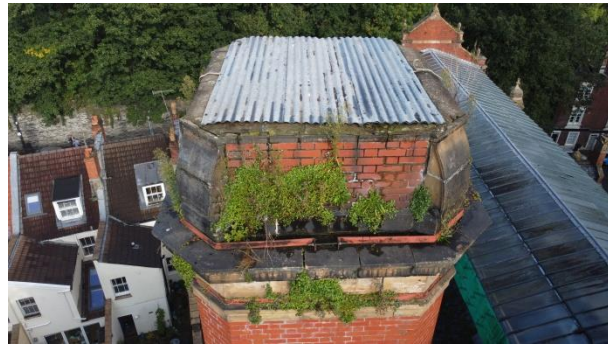
Judy Goldsmith reports that the rubble from the top of the chimney was dropped inside, and the top was capped, see below.

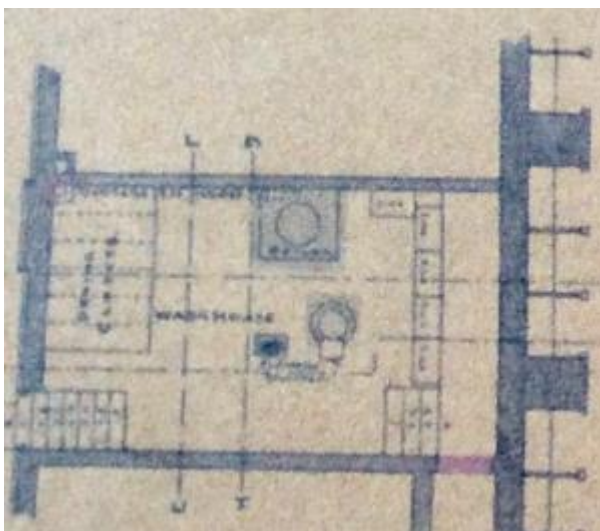
(Left) Detail from a 1930 plan

The Wash House used to wash towels and hired bathing costumes. The plans show sinks, a coal fired boiler, drying closets on rails similar to ones in other swimming baths, steps up and down. In the centre may be a Victorian washing machine, with a crank handle. The wash-house was in the South wing separated from the smithy leading into the women's warm baths. Two extra sinks have been added since the 1880's layout.

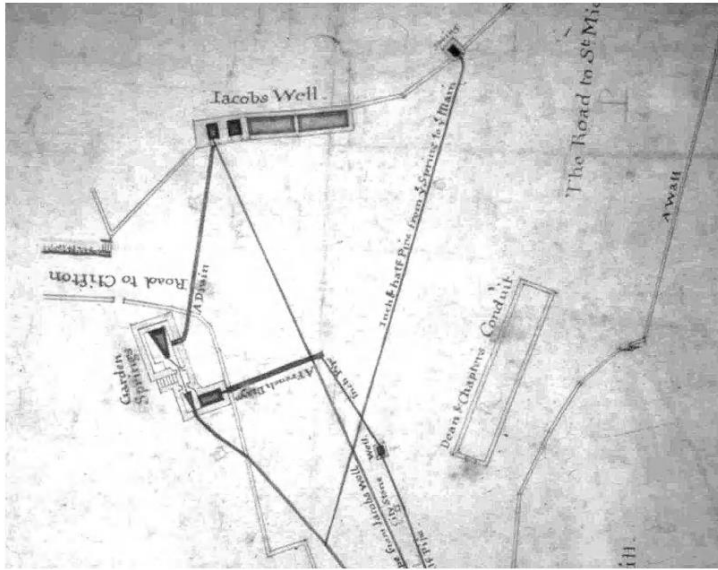
Fig. 8. William Halfpenny's plan of 1742 showing Jacob's Well and the dean and chapter's conduit (by courtesy of Bristol Record Office).

The Transactions of the Bristol and Gloucestershire Archaeological Society Volume 122 reproduces a plan of 1742 on page 144. It shows three springs and several cisterns supplying a main running southwards along Jacobs Wells Road. The 'reservoirin the

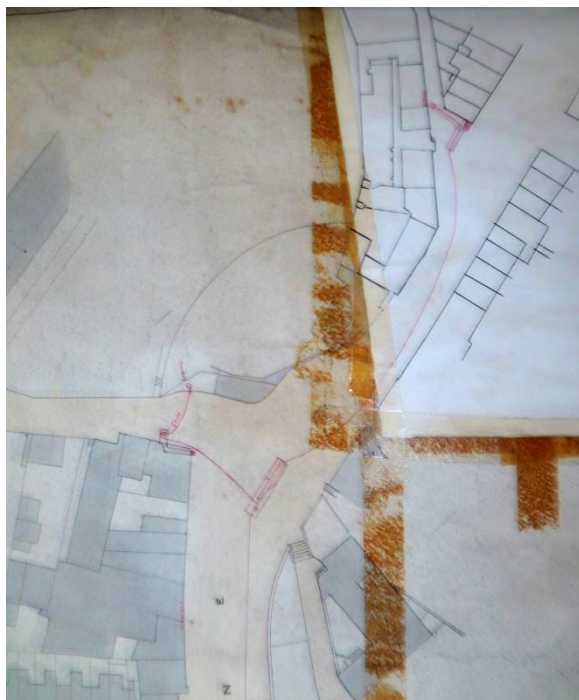
This plan, said to date from 1887, shows different routes for pipes from those on the eighteenth century plan above, connecting to the old Dean and Chapter's Conduit.

The marking up may date from Thomas Mogg's tenure as Superintendent in the 1960's. The red ballpoint pen and paper additions indicate settling tanks or chambers and a spring-water supply at the bottom of Constitution Hill and Gorse Lane.

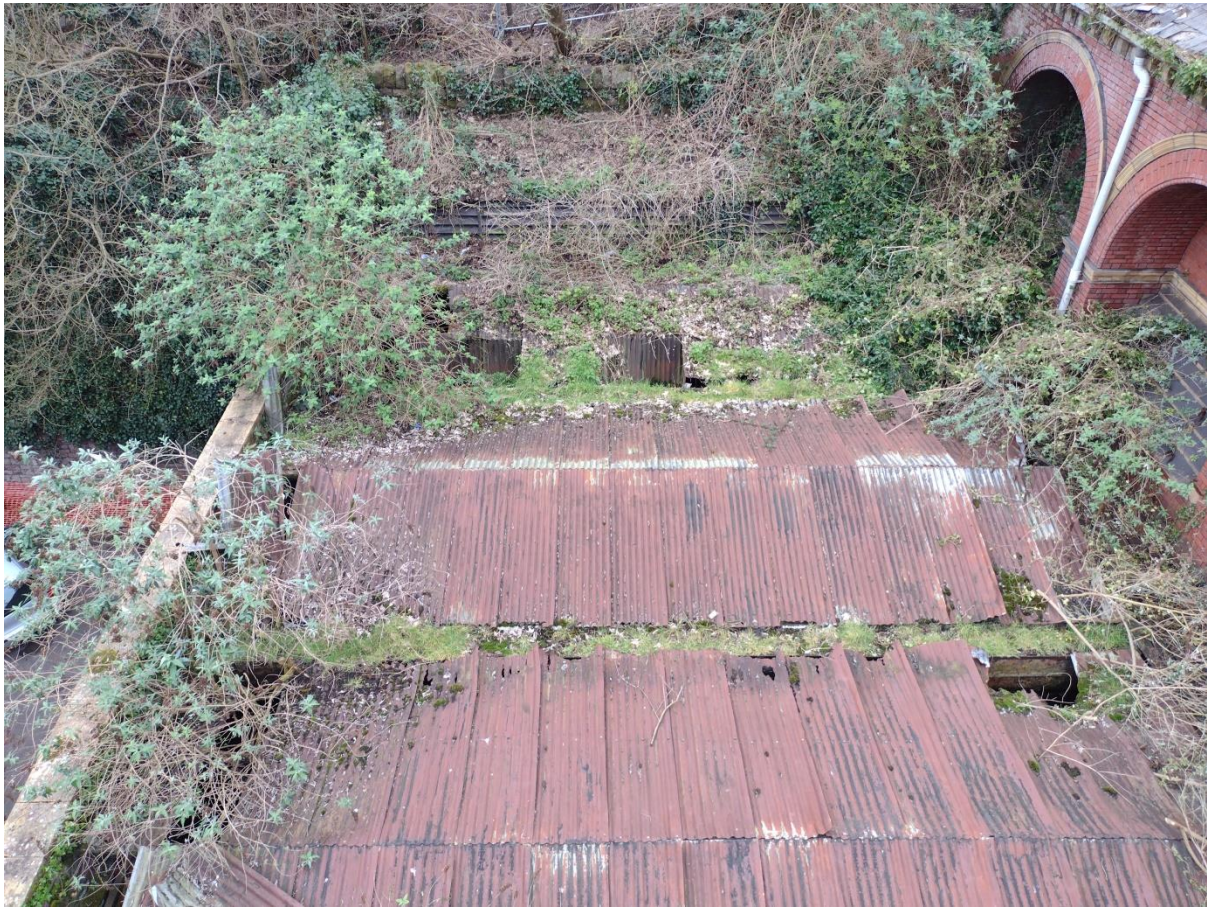
4.0 THE TANKS

In 1888 Sampsons quoted for a tank to store the spring water. It is made of three individual tanks constructed of sections of grey cast iron bolted together. Plates are approximately 5/8 inch thick. No founder's name has been seen on the castings.

The three tanks are located above the boiler room, supported on 4 large cast iron columns 21' high , They stored spring water and were probably intended to settle out silt and sand, as well as providing bulk storage for filling the pool.

The tanks are roofed by corrugated sheeting nailed to simple timber trusses. Sheeting is in poor condition and has failed over about 10% of the eastern tank, 5-10% over the central tank and at least 60% over the western tank. Here the roof is covered by trees and established vegetation.

The tanks were inspected as far as access from a MEWP would allow. No vegetation or roofing sheets were removed, so the extent of the survey was limited, and the report on the tanks is preliminary. Further inspection is recommended when scaffolding is in place.

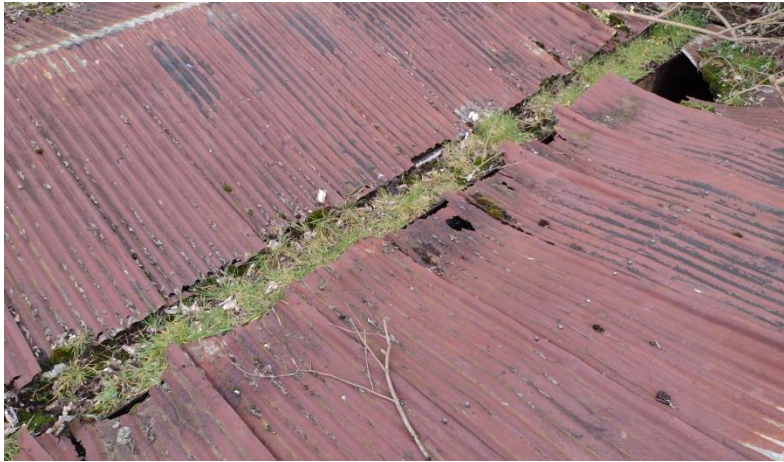
The three tanks are believed to be separated by a small gap, probably around 4 inches wide. Each gap is spanned by a cast iron gutter 18 inches wide into which the roofs drain. Both gutters are full of grass and it is not currently known how or where they drain.

All three tanks are full of relatively clear water. Rough measurement suggests that the westernmost tank contains 1.4 m depth of water, whilst that on the east is 1.2m deep. During the current survey it was not possible to establish how the three tanks interconnect or why the depth of water in them is different. It is probable that the surface of the water in the eastern tank now stands lower than its original level.

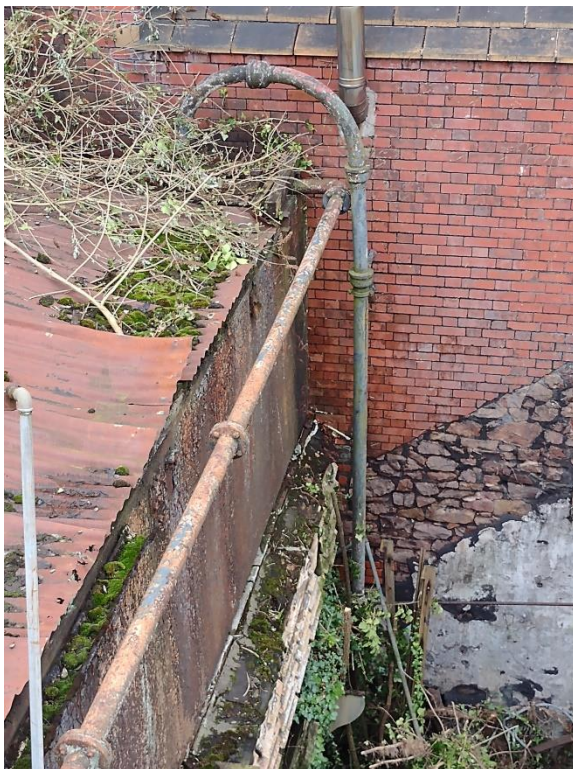
A live supply of spring water still enters the eastern tank. Its entry point was beyond the reach of the MEWP, but the arched cast iron pipe illustrated is believed to be the supply.

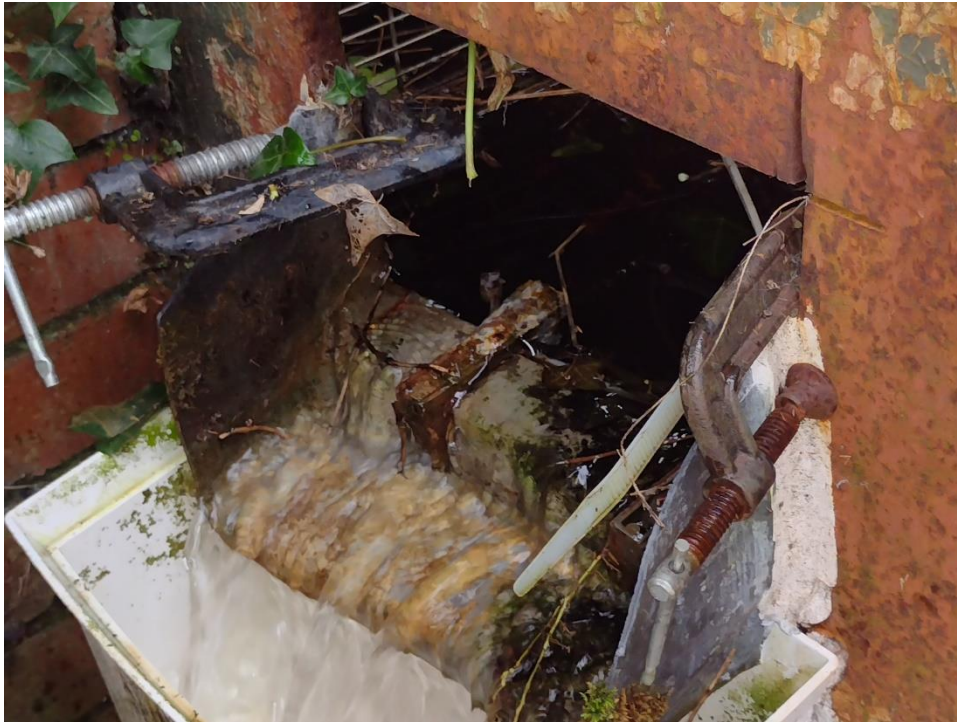
In recent years the overflow pipe at the south eastern corner of the tank rusted through, and water overflowed into the masonry and thence to the adjoining car-park. In response to complaints from the neighbours, Bristol City Council appointed contractors who used an angle grinder to cut a rectangular drainage hole through the historic side plate and 'G' clamped on a steel chute at a level lower than the original overflow, about 7 m above

ground level. This delivers a continuous flow into a PVC hopper-head which is run via a rainwater pipe into the drains below ground.

The route of all drains should be traced before an attempt to drain the tanks is made.

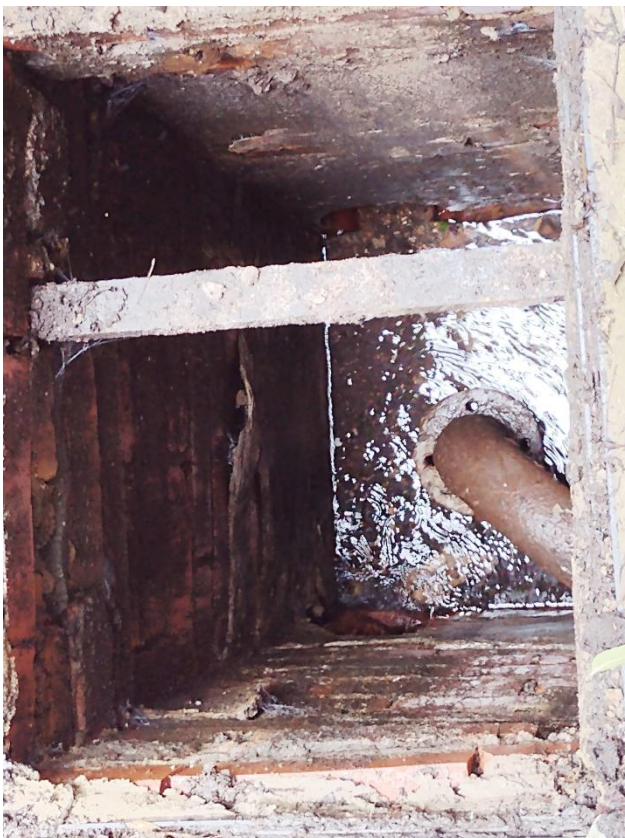
The route of the drain is currently unknown but outside the boiler house entrance door spring-water in a brick-lined chamber runs continuously north to south through drains. A flanged cast iron elbow entering from the north west corner appears to have been a drain, but it is not known where any of these pipes run from or to.

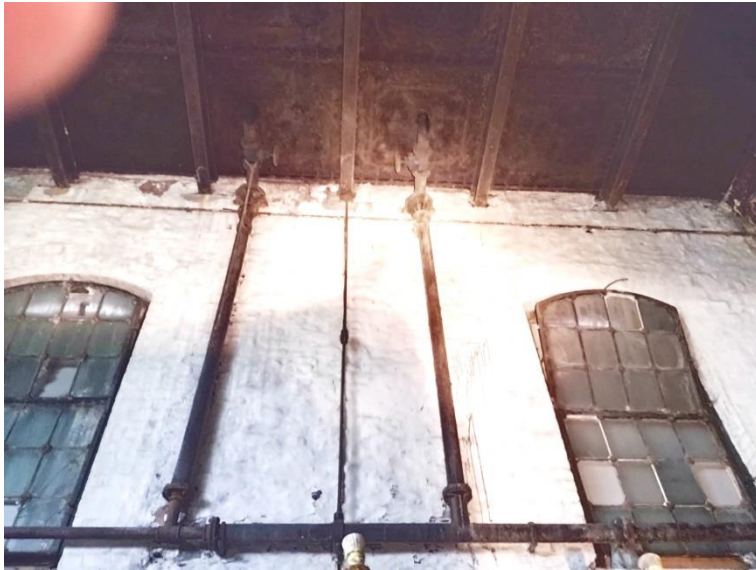
Each tank was drained by opening a gate-valve which feeds into a cast iron hopper-head and downpipe attached to the south wall of the boiler house.

These connect to a horizontal iron & steel pipe which runs eastwards and down to a drain adjacent to the entrance door.

The east end of this pipework has been replaced in steel as

to a drain. Its route and the condition of the drain should be established before the tanks are emptied through these pipes.

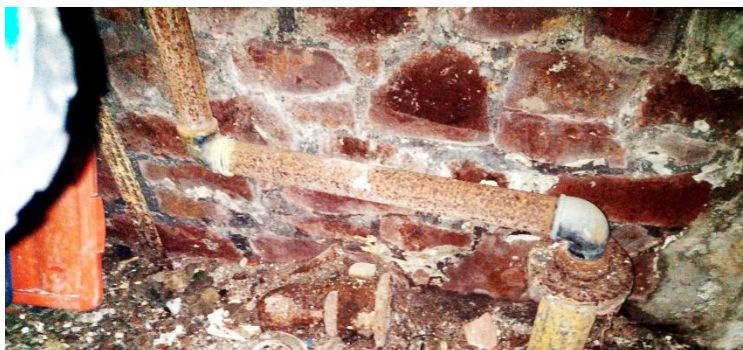
illustrated below, but the original cast iron drain pipe is still in place and probably connects

It is possible that one or more of the existing gate-valves can be opened but this will require the services of a specialist metalworker and a scaffolding to each valve.

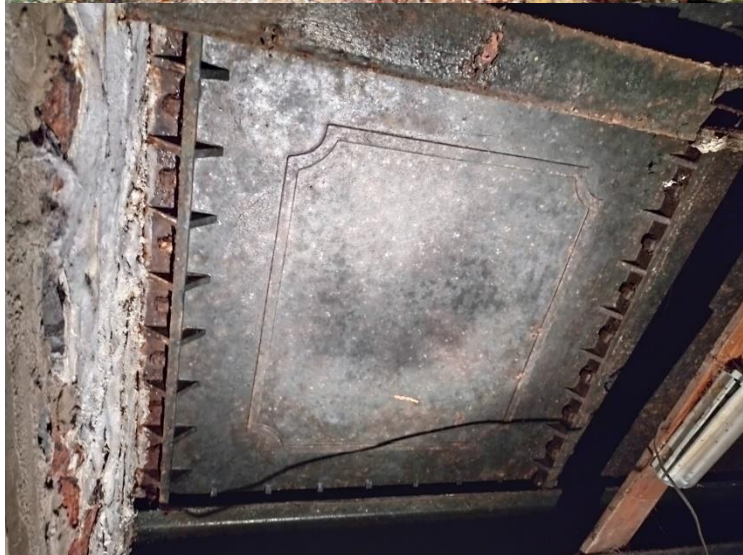
The condition of the tank's castings and cast iron pillars are good where visible, but the material is brittle and may contain unseen cracks.

The steel beams that support the tanks have corroded, but the extent is currently unknown.

Small areas of calcification provide evidence of past minor leakage, which may still persist.

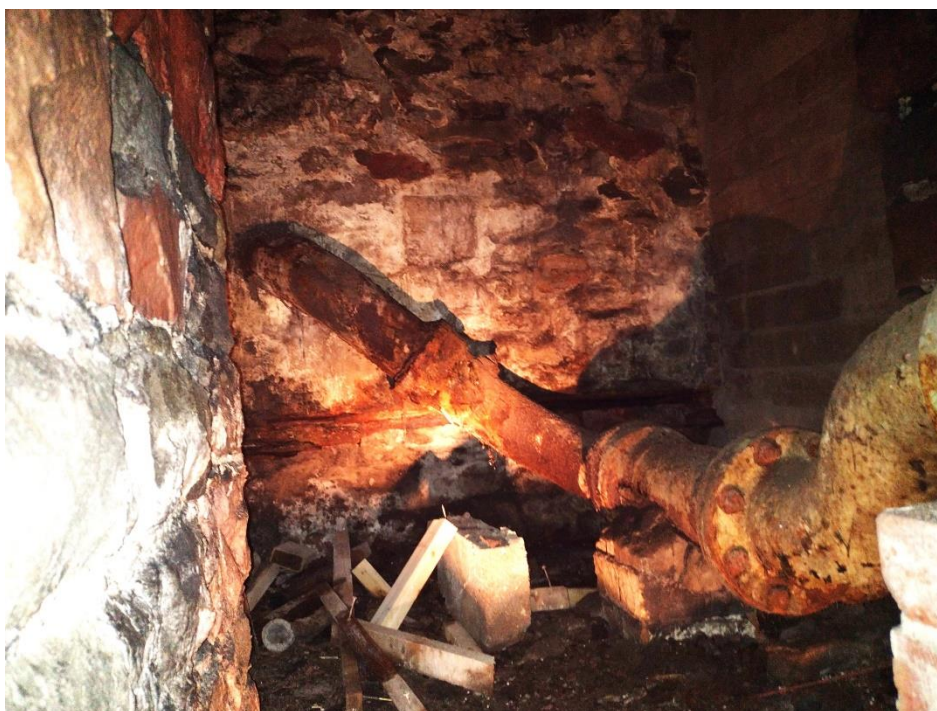
The photograph above shows the original cast iron pipe that supplied warmed water to the pool. A cast iron elbow turns the pipe horizontal to a point where a later steel or ductile iron pipe has been bolted on, now connected to the outflow of the calorifier, see photograph below. The large steel pipes in this area may date from Paterson's installation of 1933-4, see pages 22 ff.

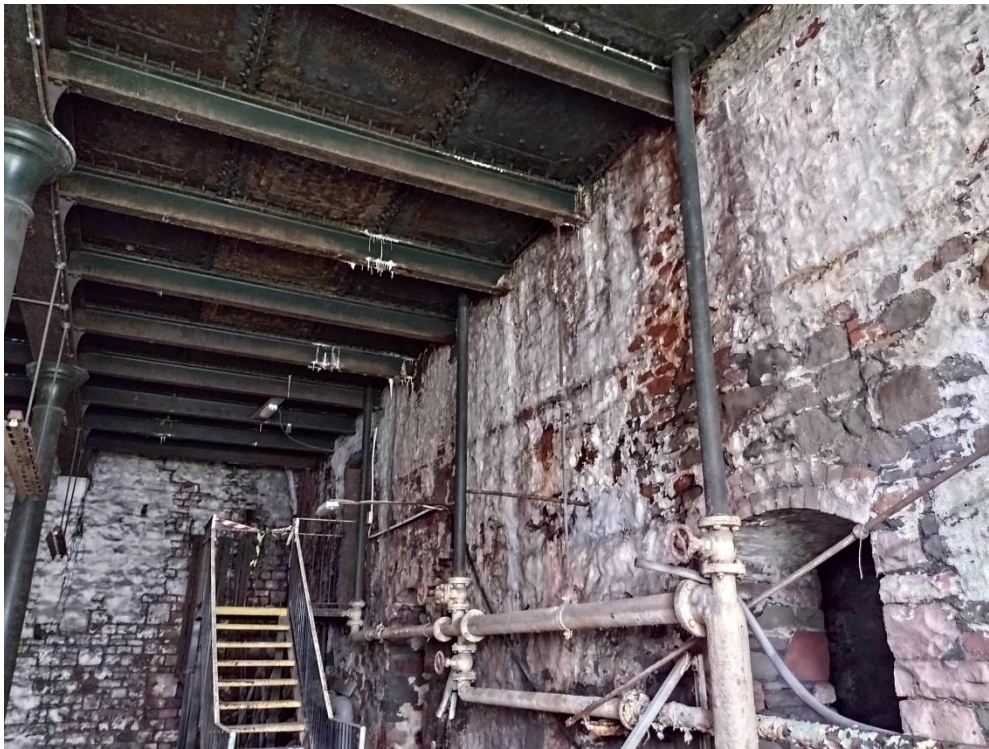
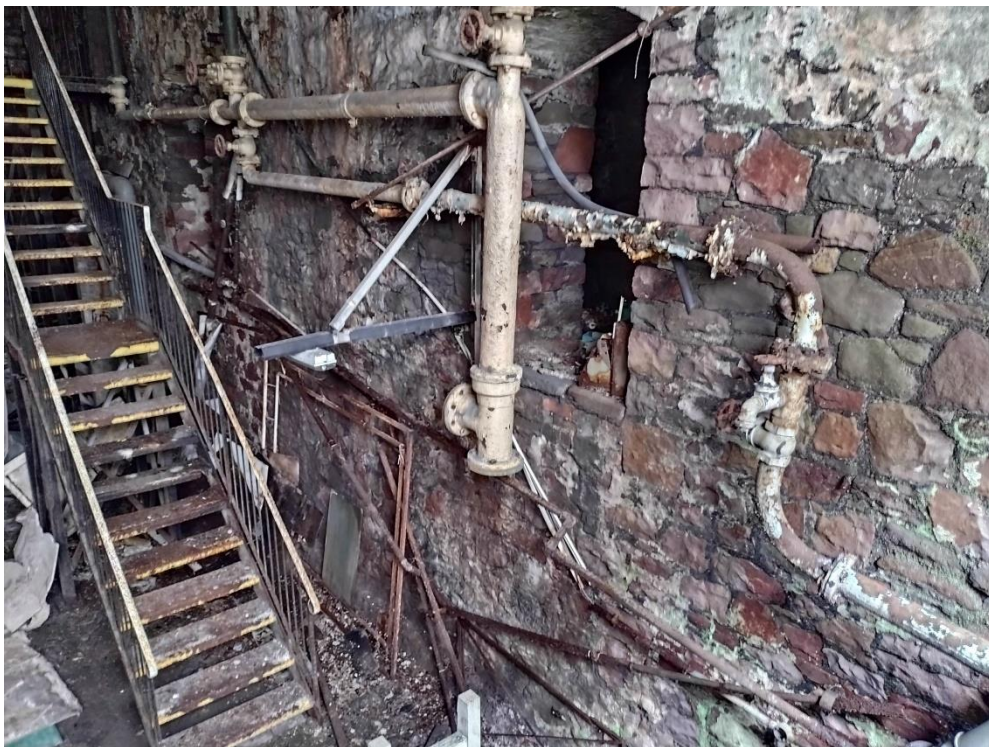
In the upper photograph the three vertical cast iron pipes carry water from each tank down to a common horizontal main via stop valves. From the centre of this main a smaller pipe runs eastwards, either to drain or to a currently-unknown destination.

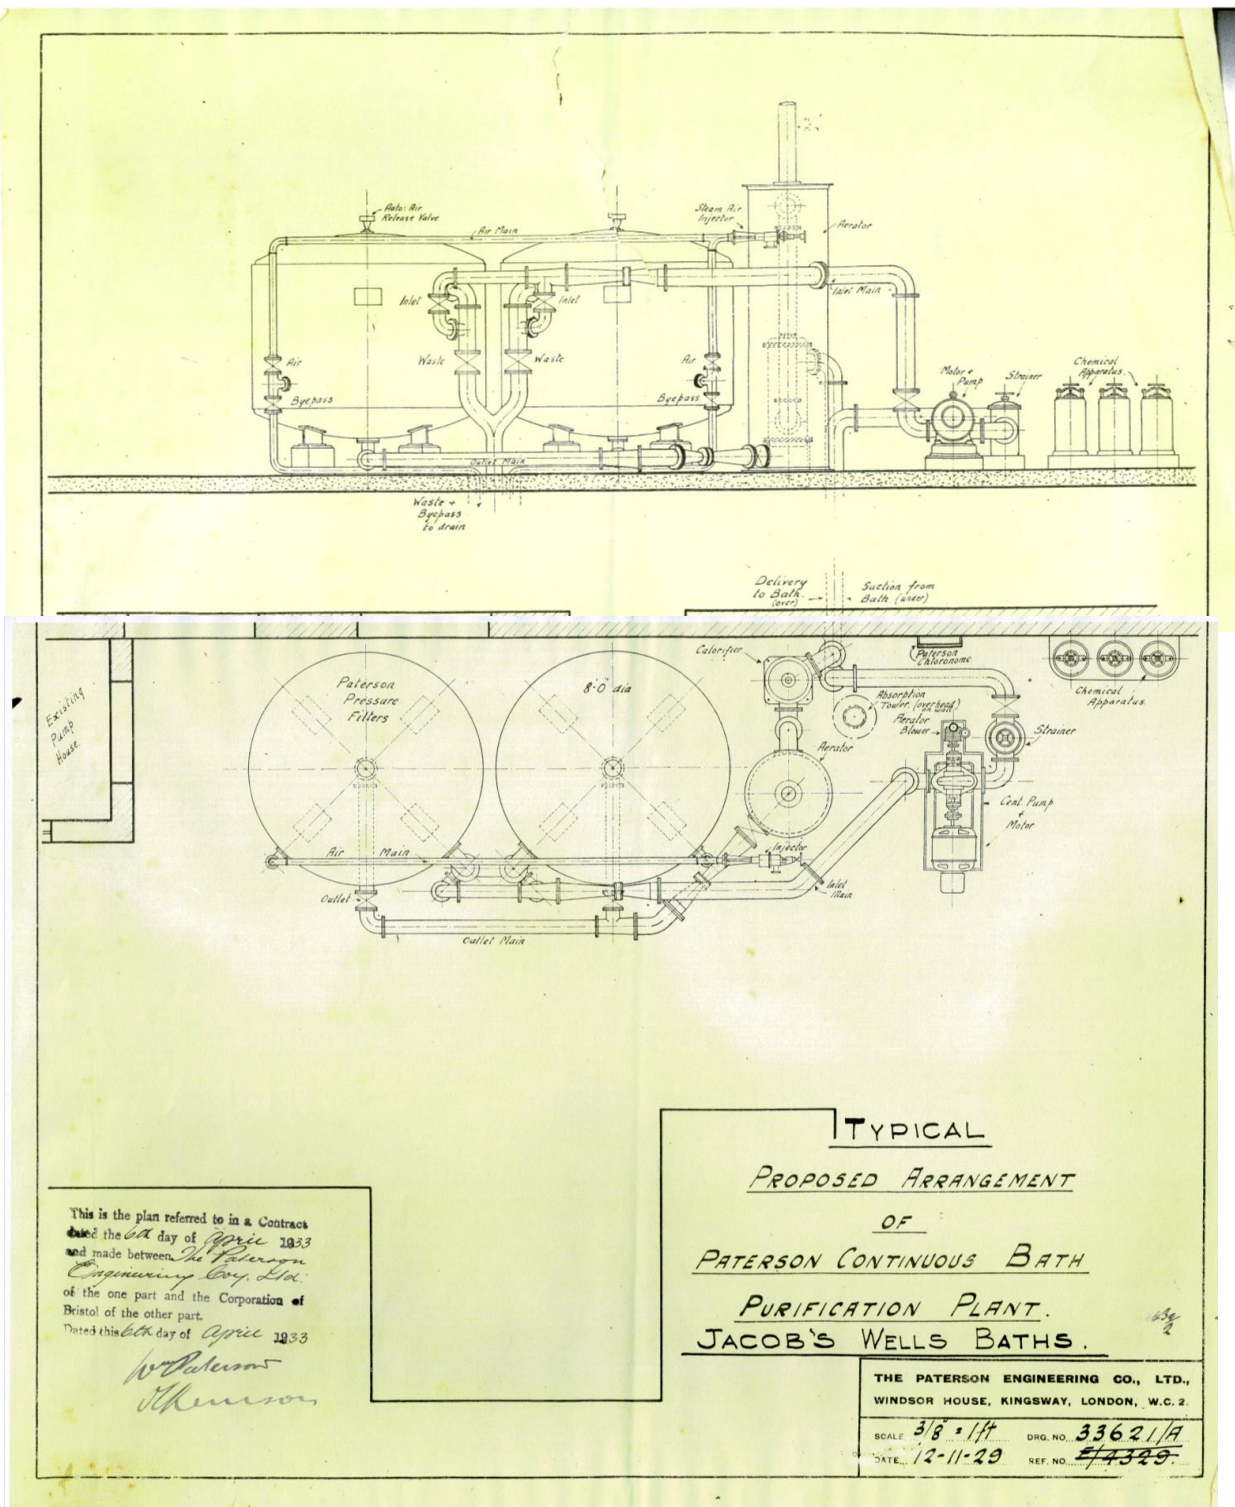
The drawing below is marked 'Typical' and shows Paterson's standard arrangement. At Jacobs Well Baths the connecting pipework appears to differ from the drawing, but it may be assumed that the equipment installed in 1933-4 was more or less as illustrated.

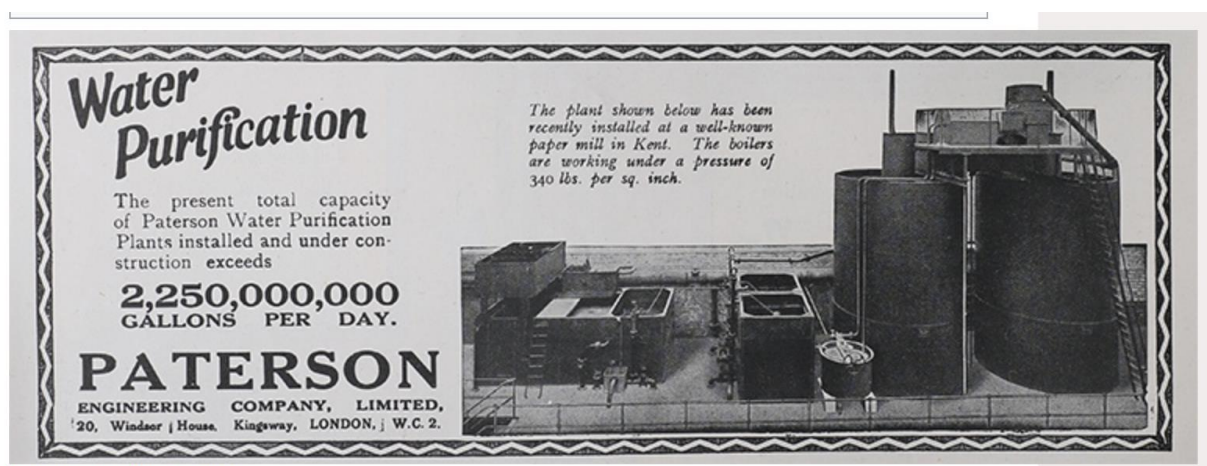
This illustration of large industrial purification equipment dated 1929 installed in a paper mill may give an impression of the type of equipment probably used at Jacob's Well Baths.

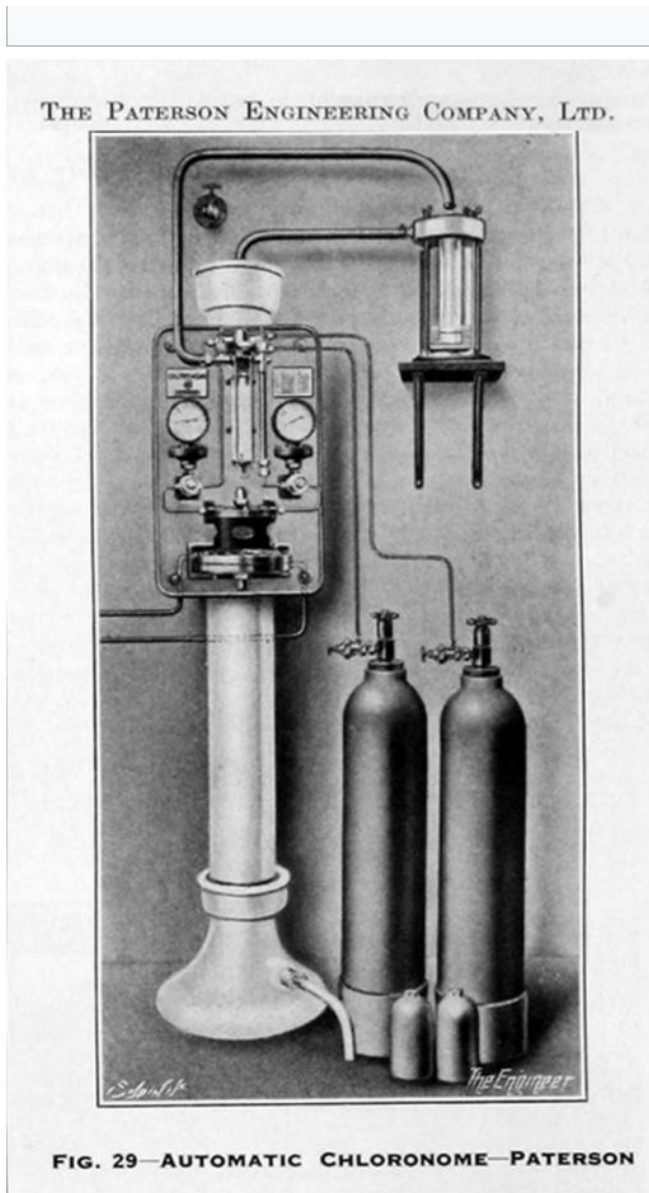
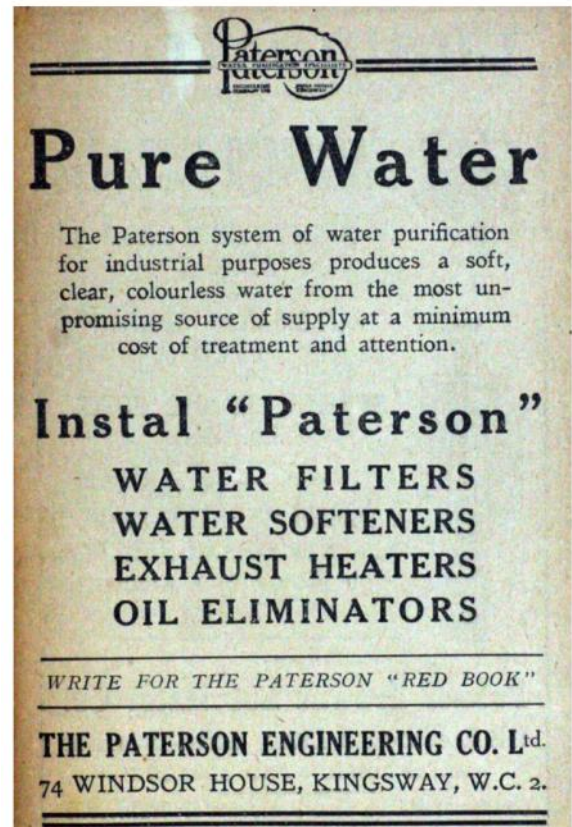
The drawings refer to a 'Paterson Chloronome' which is illustrated (right) below, dated 1933. One was probably installed at Jacob's Well Baths.

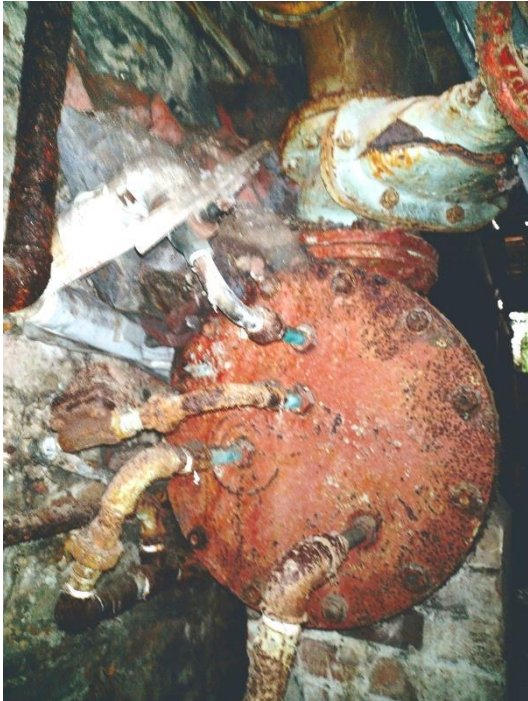
The current calorifier is a steel drum 6 ft long , 16 ins diameter, flanged at one end. To this is bolted a cover into which are threaded a pair of $\frac{3}{4}$ inch diameter brass pipes which are believed to be the flow and returns for copper heating coils inside.

This circuit was probably heated by a modest-sized boiler below, but the output of this system must have been too small to have much effect on the temperature of the pool, if full of water.

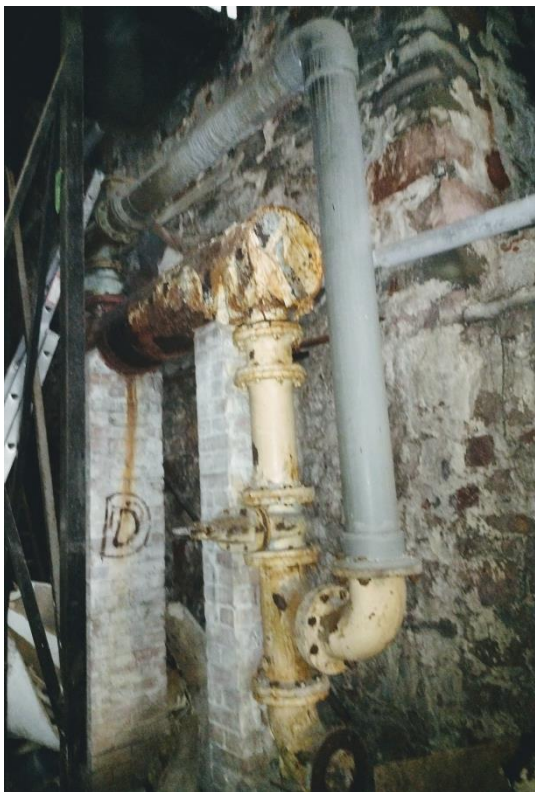
The calorifier is connected between large steel supply and return pipes that probably date from the Paterson installation. The photograph to the left shows the return pipe bringing cool water from the pool. Branched from it is a grey plastic PVC pipe which is believed to be a later bypass.

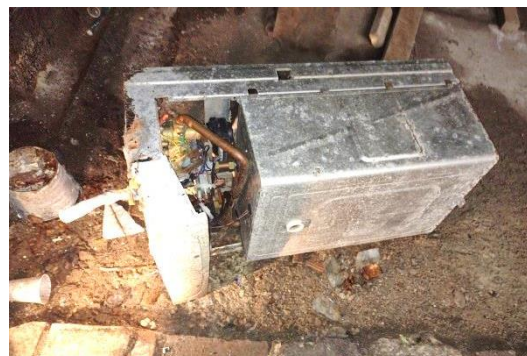
A modern natural gas boiler lays derelict in the boiler house (below) but it is not known where this was installed

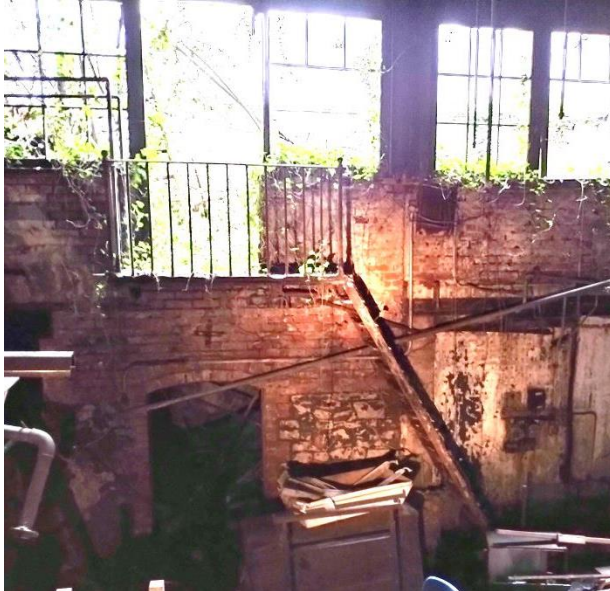
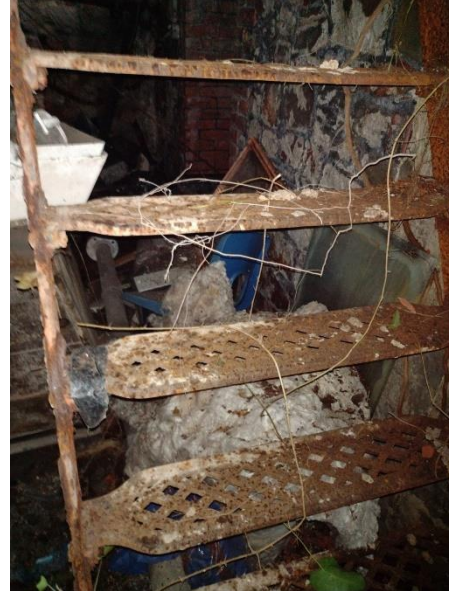
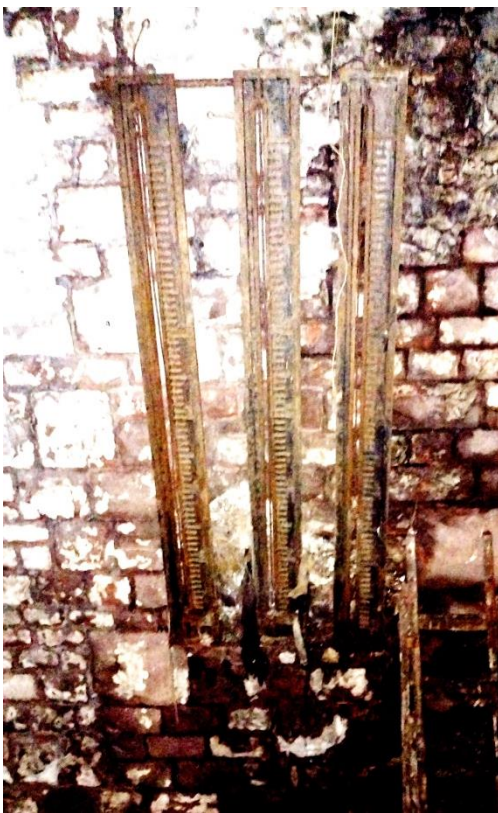
The cast Iron staircase up to the former blacksmith's shop appears almost complete and amenable to restoration and strengthening for re-use.

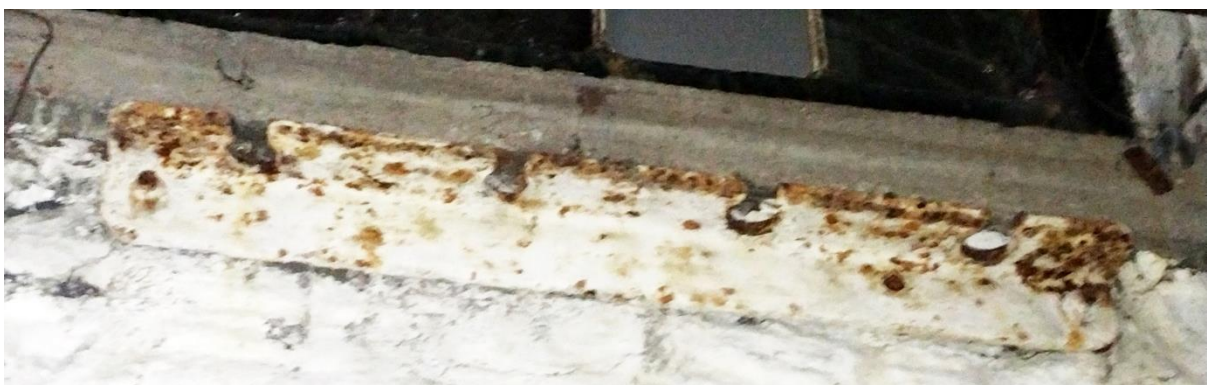
One of the original forged entrance door hinges survives and could be replicated for new doors of period design.

BELOW: This rack once suspended the boiler-man's fire irons. The fires inside traditional horizontal boilers are long and require log-handled tools, so the bracket on which to hang the tools is mounted high on the wall.

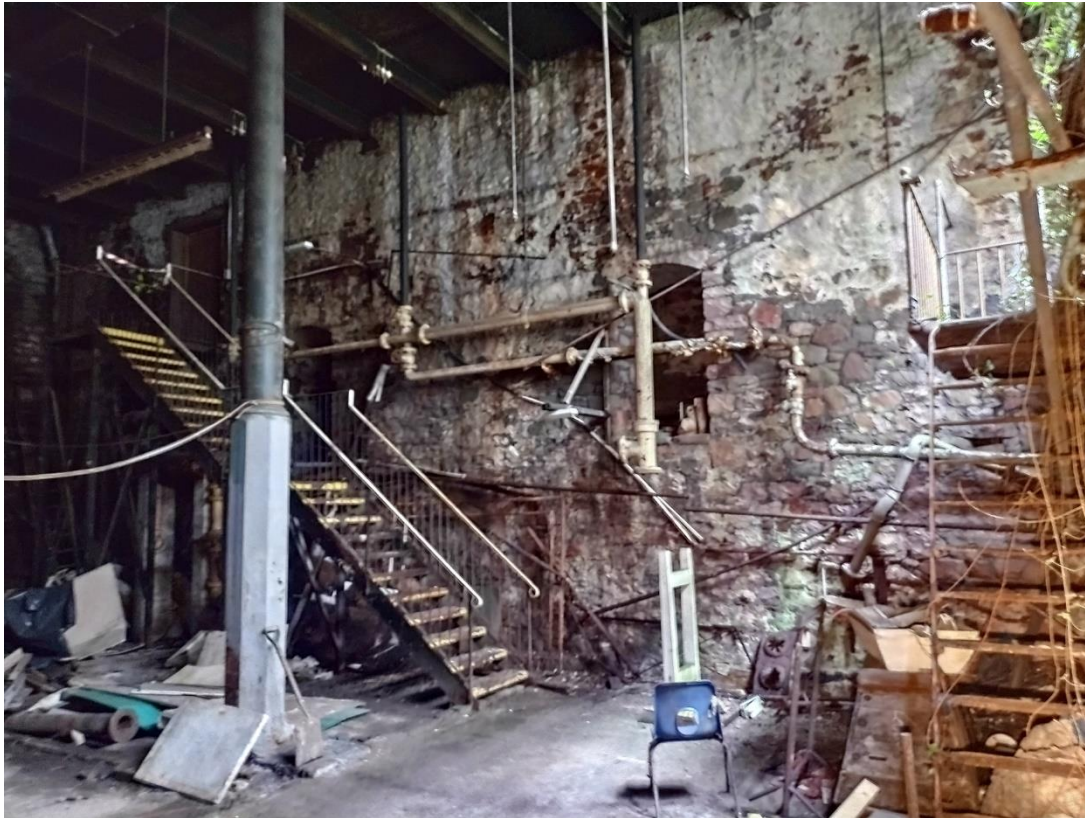
This late 20th century steel staircase is understood to have been made and installed by Scotties Gates Ltd of Bristol. It has no historic value and may be cheaper to renew than to restore and paint.
